Advanced Turbine Technology

ATTAP

1989 Annual Report

Allison

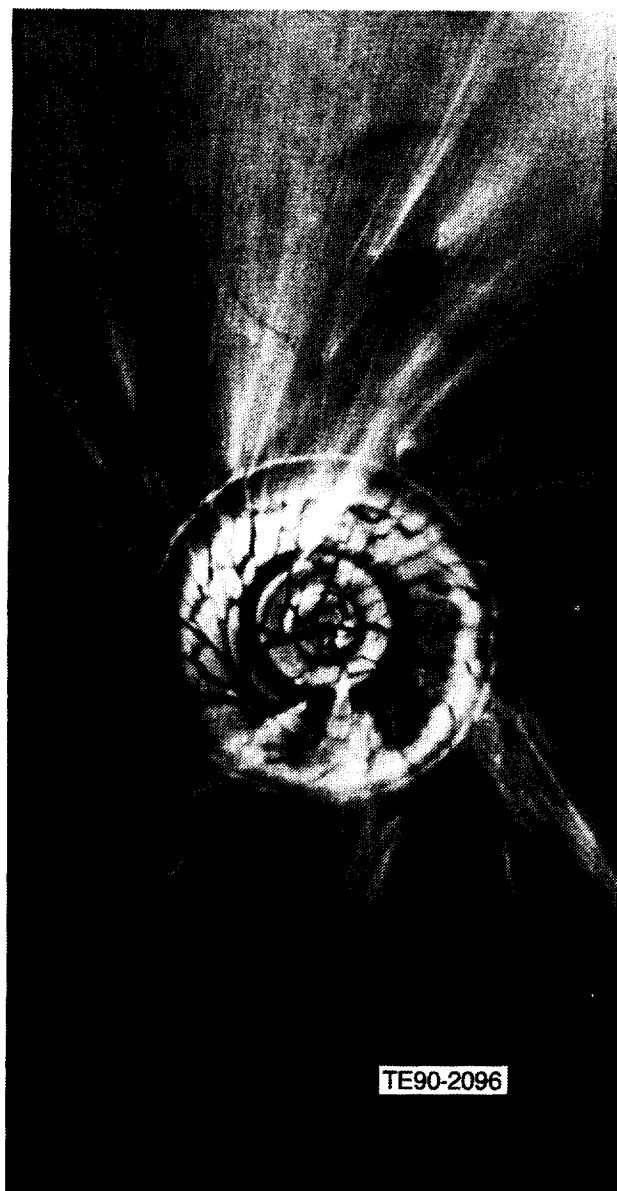
Figure 94. CBO HIPed SiC rotor hub burst at 131,500 rpm.
